WEST BAGHDAD INTERNATIONAL  
AIRPORT SPECIAL FORCES BARRACKS  
BAGHDAD, IRAQ

SUSTAINMENT ASSESSMENT

**SIGIR PA-07-100**

**APRIL 24, 2007**

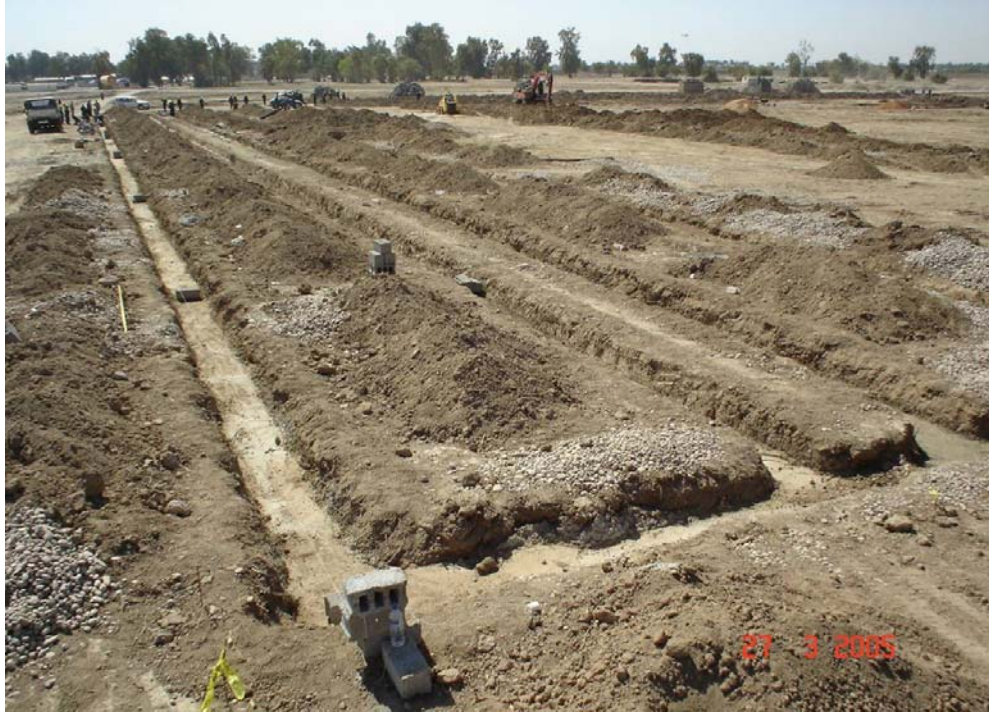
USACE<sup>1</sup> Construction Progress Photo 1 shows that the construction took place on a level and accessible site that was adequately cleared before building construction started. USACE Construction Progress Photo 1 also shows that the cleared open field was prepared, dug and compacted in preparation for installation of a barracks foundation. Subsequently, the trench was used as the form for the barracks concrete footing.

**USACE Construction Progress Photo 1. Before construction, the level and accessible site was cleared.**

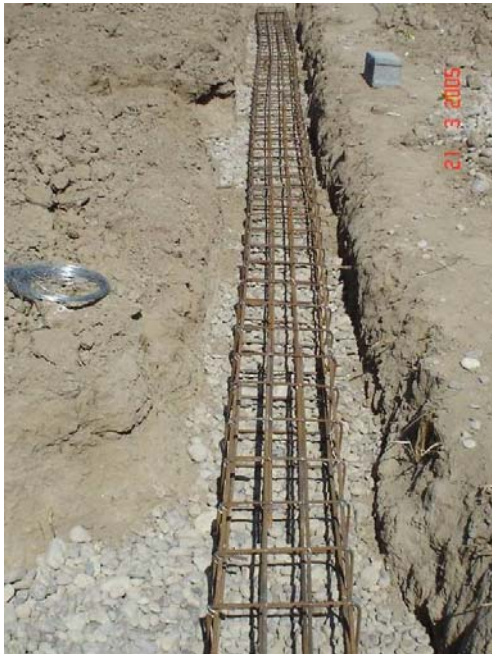
USACE Construction Progress Photo 2 shows sub-foundation rock was placed in the bottom of the trench and tied rebar was properly placed before the footing concrete was poured. USACE Construction Progress Photo 3 shows the footing after concrete was poured to make the buildings' footings.

**USACE Construction Progress Photo 2. Sub-foundation rock and tied rebar were properly placed.**

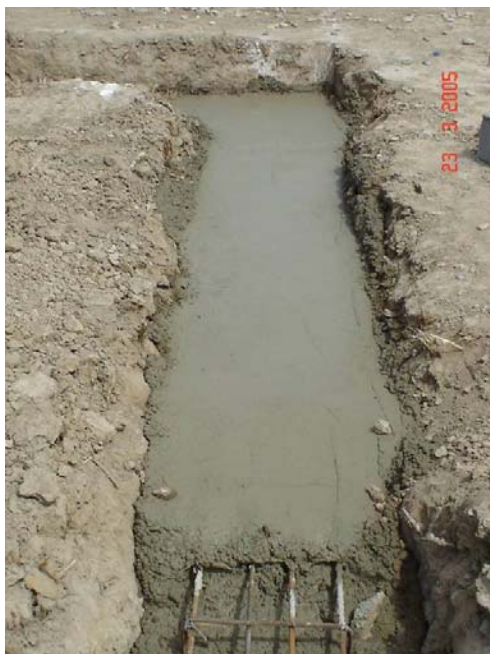
**USACE Construction Progress Photo 3. Trench following pouring concrete.**

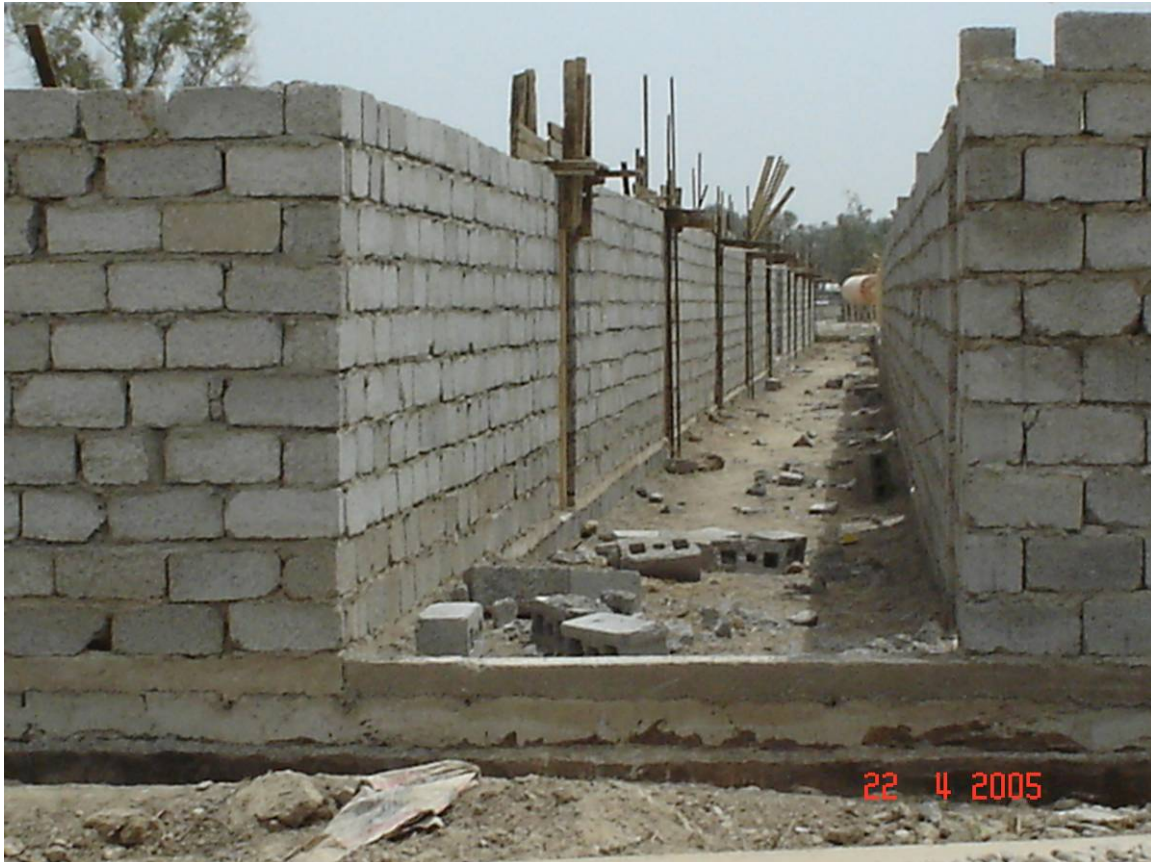
To meet SOW requirements, concrete blocks were placed on top of foundation footings to form the vertical load bearing walls of the buildings. USACE Construction Progress Photo 4 shows an example of such a wall before finish work, which included plastering and painting.

**USACE Construction Progress Photo 4. Concrete blocks were used to make load bearing walls.**

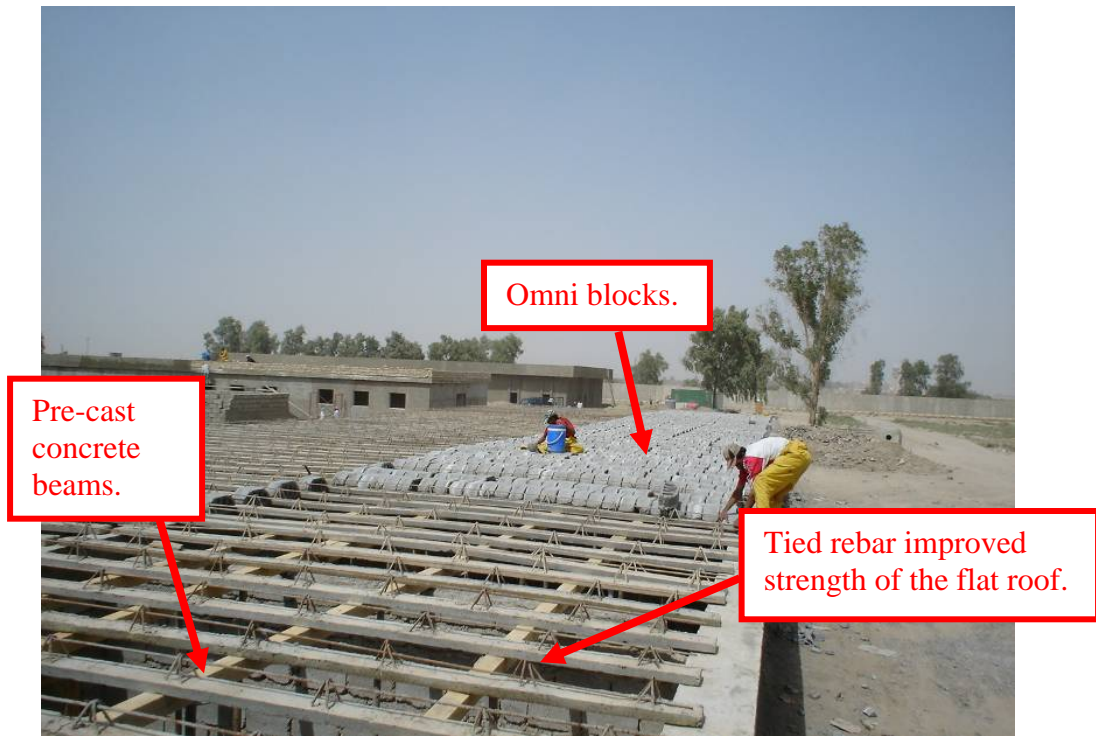
USACE Construction Progress Photos 5 and 6 illustrate stages of the construction of a barrack's roof. In USACE Construction Progress Photos 5, workers placed prefabricated "Omni" blocks on evenly spaced steel reinforced concrete beams to fabricate the roof's support structure system with tied rebar between beams. Subsequently, the roof's solid flatwork concrete was cast and clean dirt and sand was placed atop the flatwork casting and leveled before steiger plates (concrete tile) were laid in place. Overall, beam spacing and "Omni" block placement appeared even, straight and uniform.

**USACE Construction Progress Photo 5. “Omni” blocks were placed on evenly spaced concrete beams.**

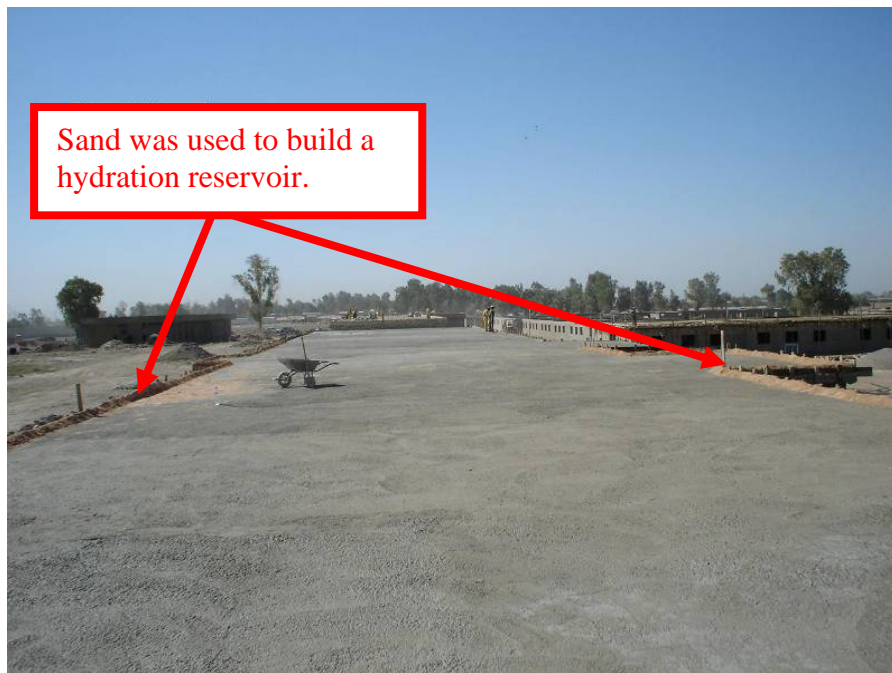
USACE Construction Progress Photo 6 taken 12 June 2005 shows the completed flatwork casting on the Senior NCO Barracks. June is a hot month in Iraq and flatwork concrete cast/placed in such conditions can dry and cure too rapidly. To slow down the drying process, sand was used to build a hydration reservoir of water above recently cast concrete.

**USACE Construction Progress Photo 6. Each Company Barracks roof was over 14,000 sq. ft.**

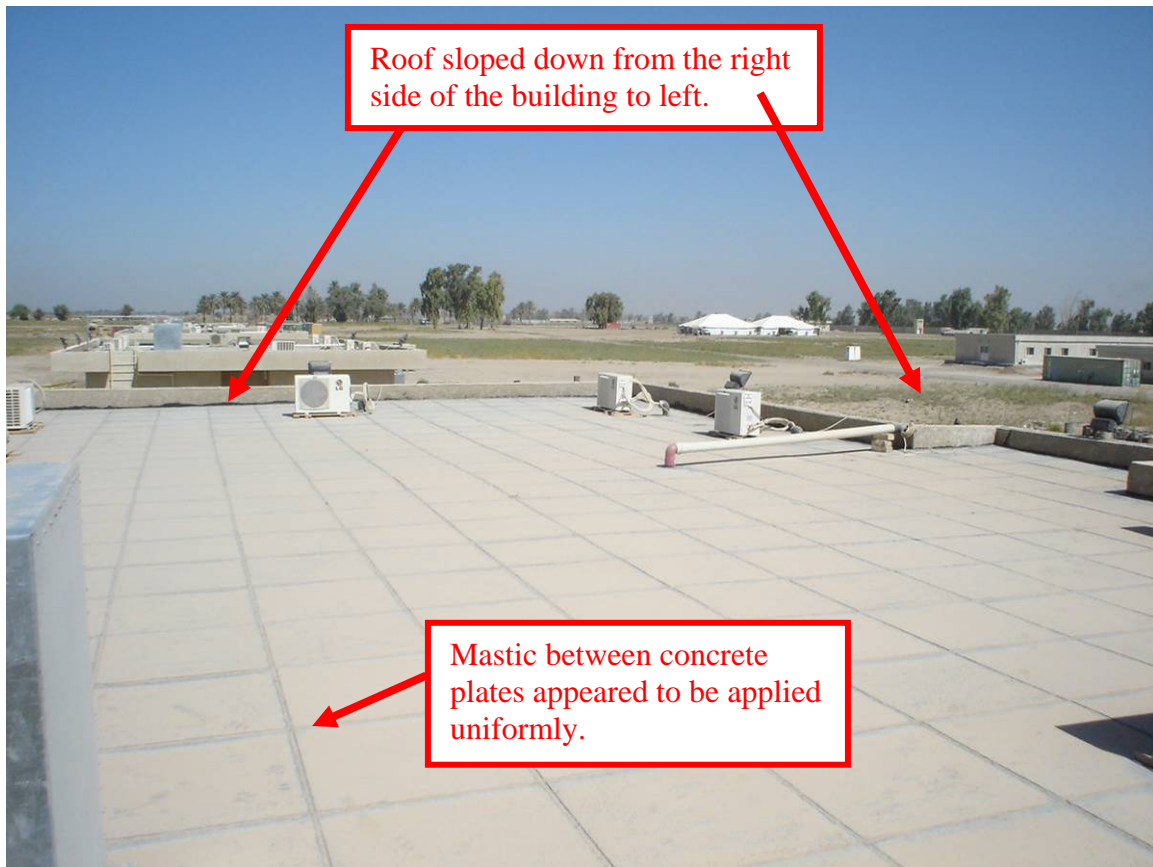
A completed roof on one of the six barracks included in the project is shown in USACE Construction Progress Photo 7. Concrete plates appear to have been properly placed and uniformly sealed with mastic to prevent leaks.

**USACE Construction Progress Photo 7. Roofs were sloped to facilitate drainage.**

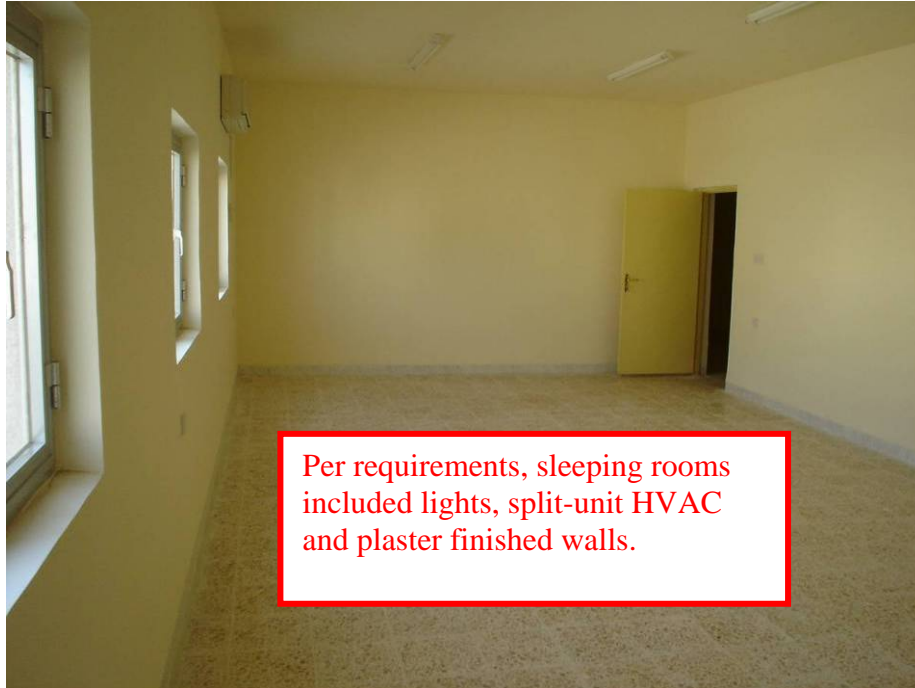
Per requirements, sleeping rooms included lights, split-unit HVAC and plaster finished walls.

**USACE Construction Progress Photo 8. Example of a Company barracks sleeping room.**

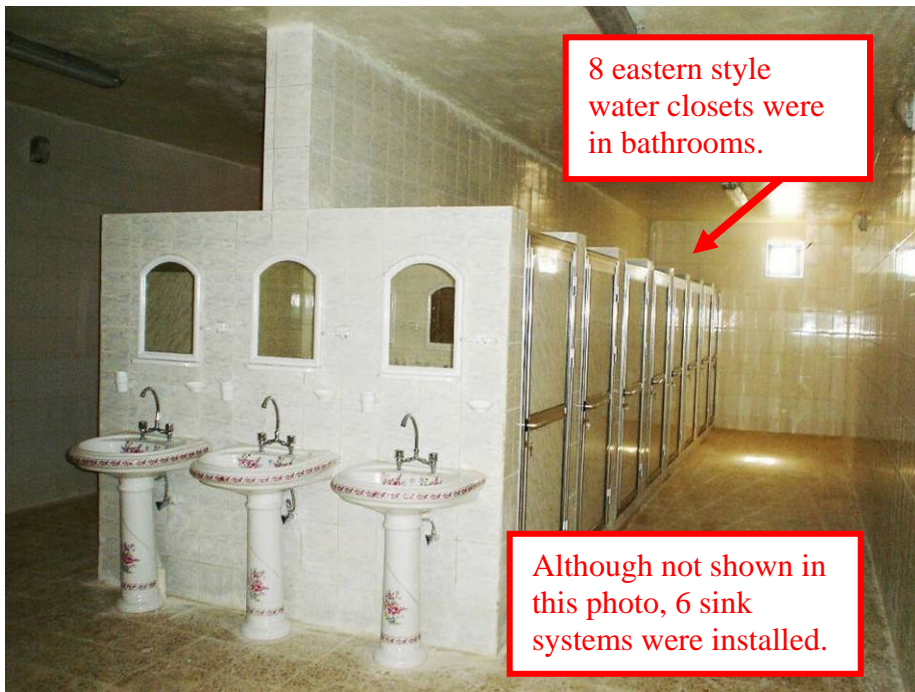
8 eastern style water closets were in bathrooms.

Although not shown in this photo, 6 sink systems were installed.

**USACE Construction Progress Photo 9. Bathrooms included required sinks and eastern style water closets.**

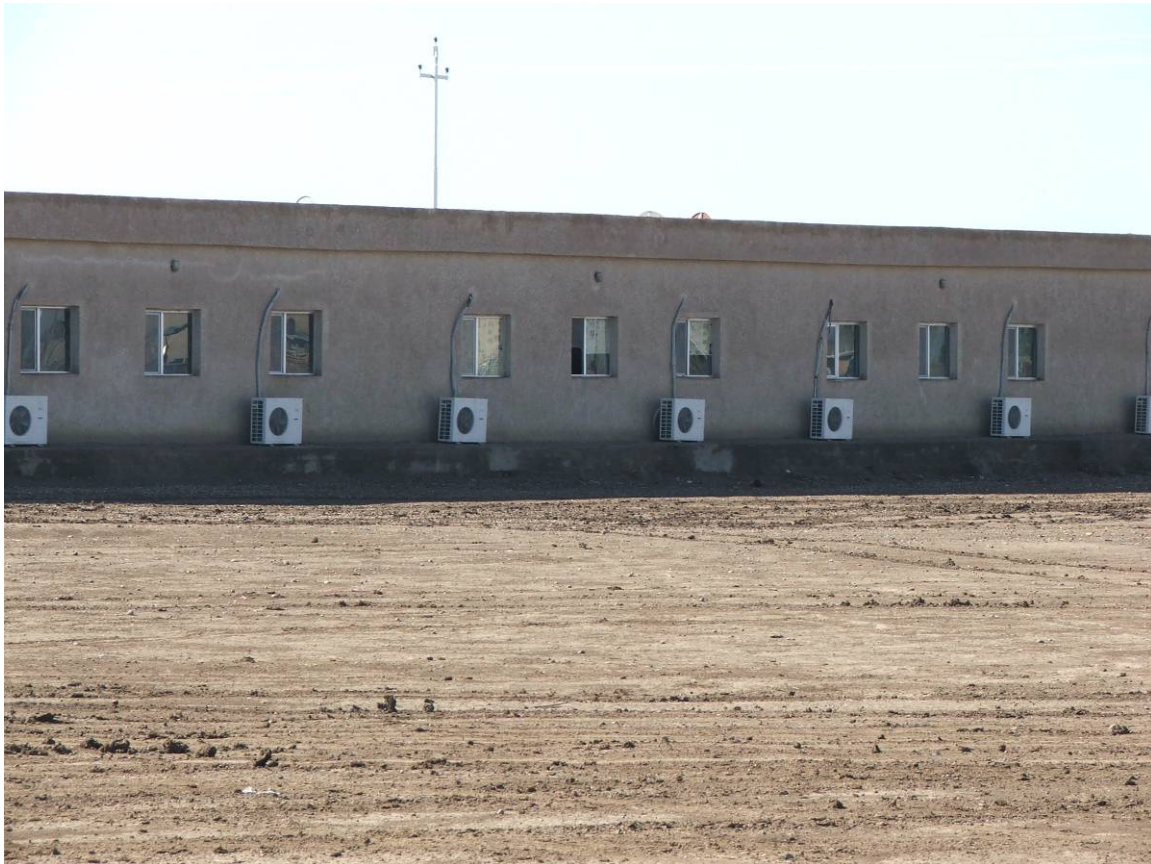
SIGIR inspectors found during their on-site inspection that the exterior of the barracks appeared to be in good condition. The exterior stucco was applied sufficiently thick and without noticeable cracks. Window and door frames were square and fit well enough that moving hinges operated freely. Site Photo<sup>2</sup> 1 shows an example of acceptable stucco work, windows, and split heating and cooling unit condensers.

**Site Photo 1. Barracks exterior appeared to be in good condition and did not show signs of settling or other major construction problems.**

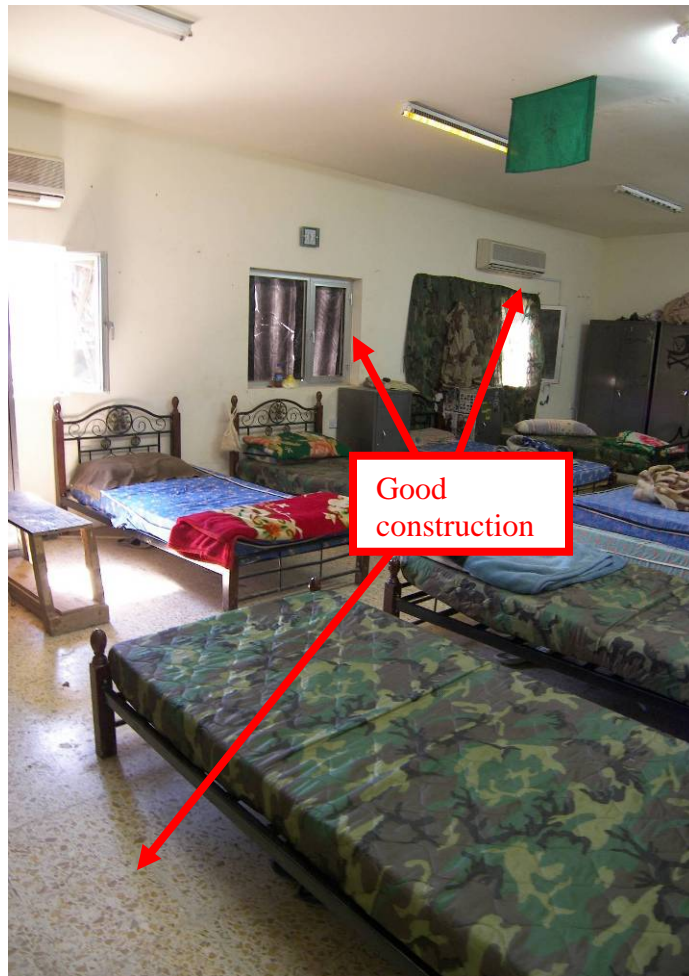
Site Photo 2 shows a typical residential area of a barracks. The inspectors observed that the windows opened and closed properly because they were proportionately framed and in good condition. In addition, the air conditioning unit was properly installed and the wiring was secured to the wall in a conduit. The floor tile also appeared to be installed properly.

**SIGIR Site Photo 2. Barracks residential area without noticeable construction or maintenance deficiencies.**

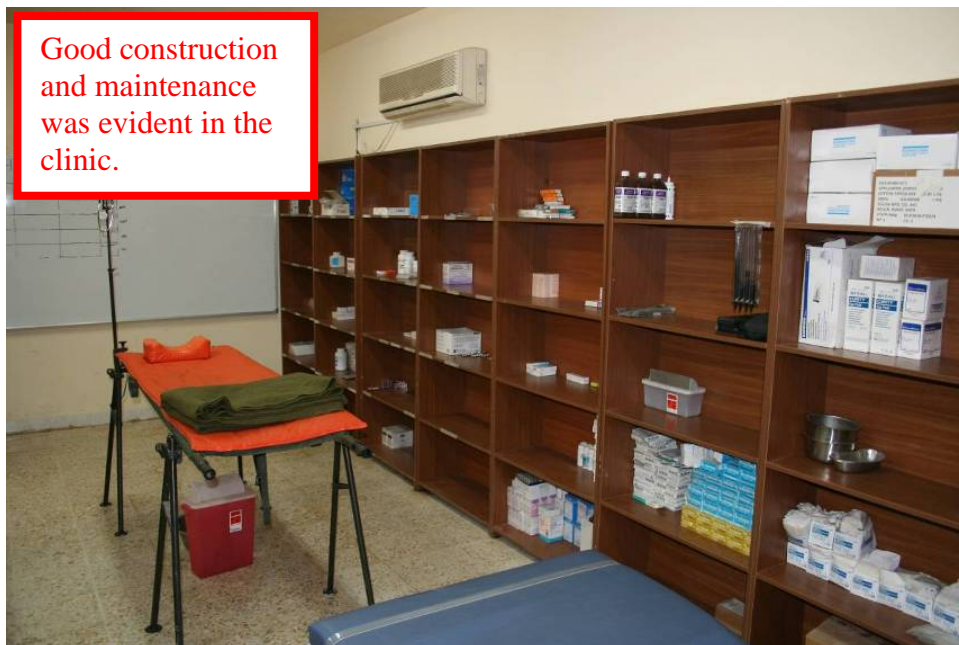
The barracks clinic is shown in Site Photo 4. As shown, the air conditioning unit appeared to be in good condition and installed properly. As in other rooms observed throughout the complex, painting and floor tile workmanship appeared to be satisfactory.

**SIGIR Site Photo 4. Clinic appeared properly built.**

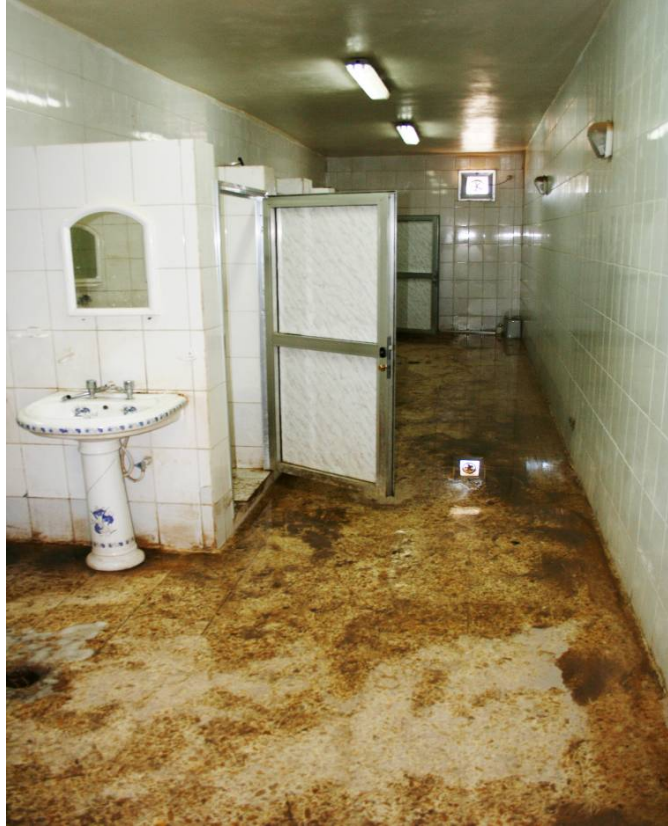
It appeared at the time of the inspection that a large number of the company bathrooms experienced drainage problems. Inspectors observed standing water in barracks bathrooms. According to dorm residents, the drainage problem was a chronic condition and had been a problem for some time. The residents claimed that the waste water backed up in many of the barracks' bathrooms and drained slowly or not at all (Site Photo 5).

**Site Photo 5. Drainage problem in barracks bathroom.**

The problems with drainage and backup in the bathrooms were likely caused by an inadequate water supply to the bathroom. If insufficient water is provided to flush drains, clogs can occur as material is not transported out of the pipes. Continued use of a water based sewage and waste water collection system without adequate water will render drains unusable as buildup grows in the pipes. In order to correct the issue of drainage to nondraining bathrooms an adequate flow of water is required.

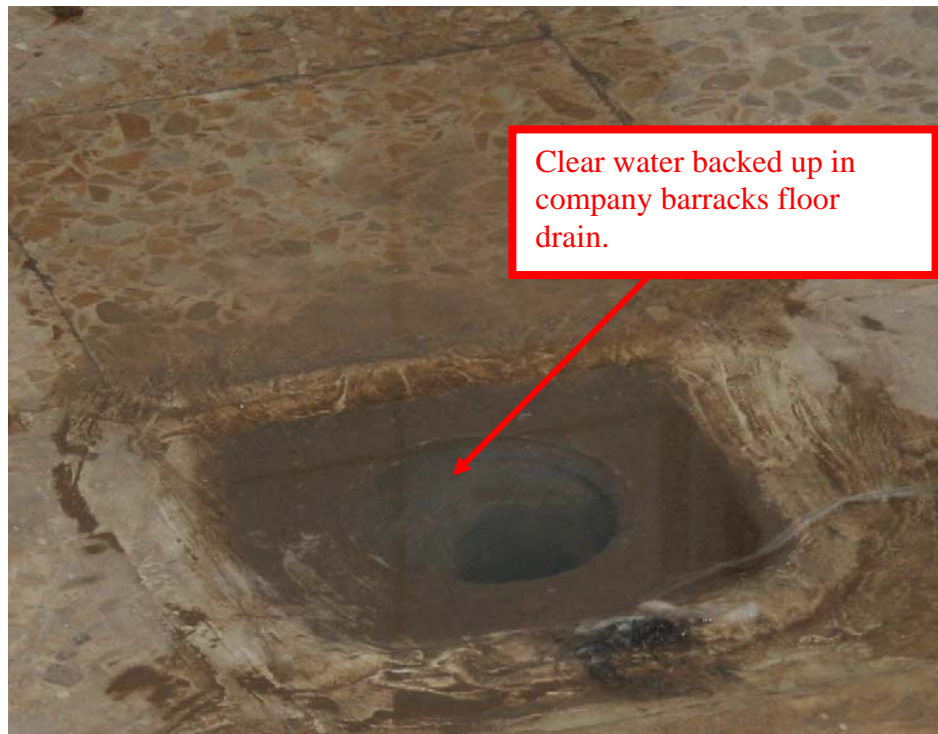
Site Photo 6 shows the clear standing water on the floor of a barracks bathroom.

**Site Photo 6. Clear water backed up in floor drain of company barracks.**

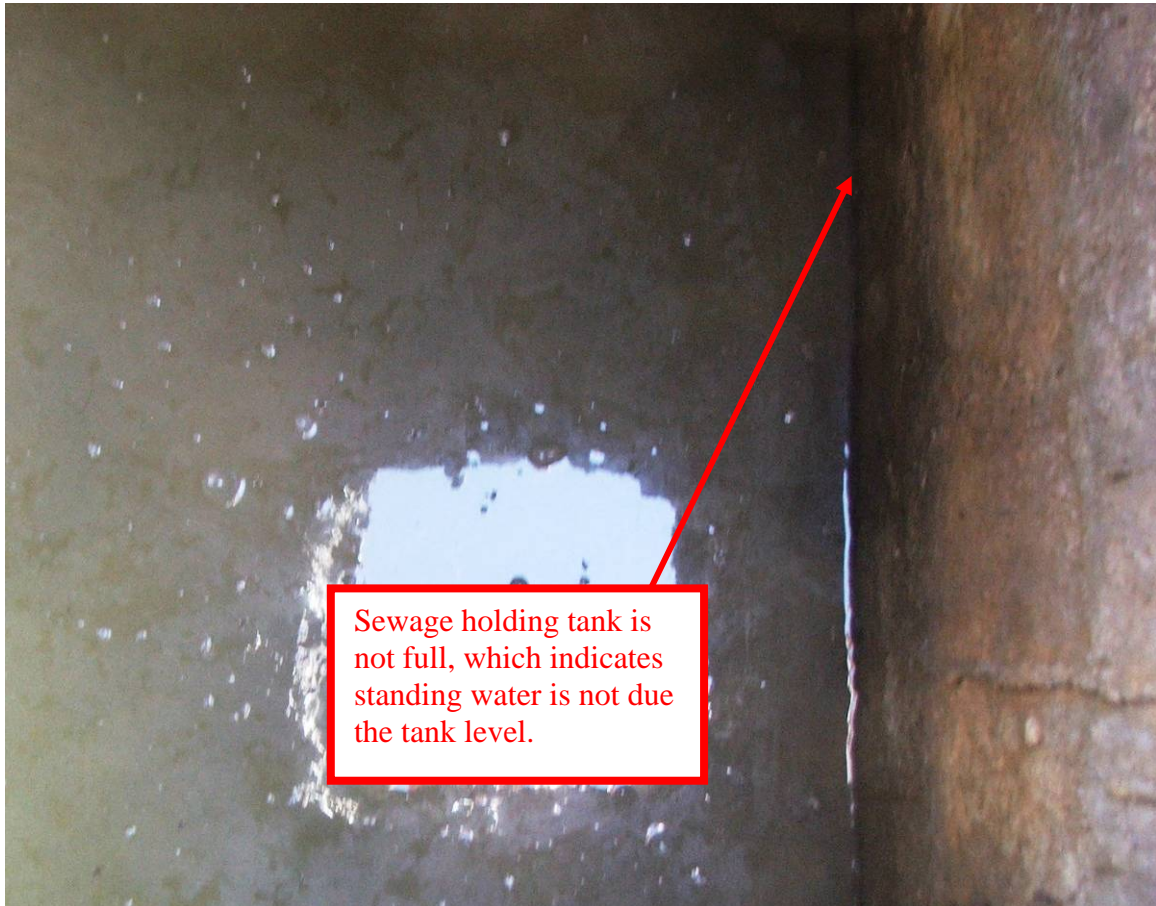
SIGIR inspectors examined the outer septic holding tank of the bathroom in Site Photo 6. Outside the barracks, in Site Photo 7, the bathroom septic holding tank did not appear to be full. With only a partially filled holding tank, the standing water appeared not to be septic backup. Accordingly, the water standing in the drain was clear which also indicates the backup was not septic system water.

**Site Photo 7. Sewage tank outside company barracks.**

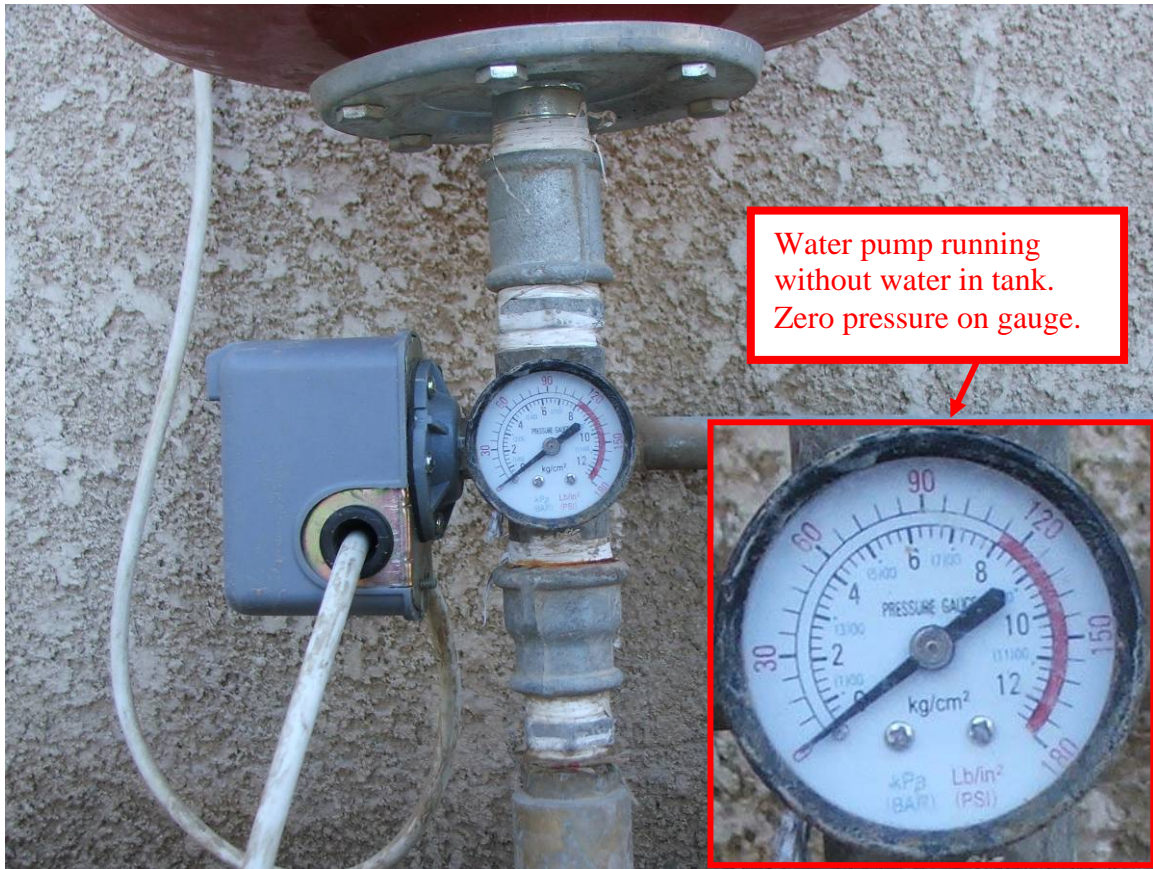
The water supply tank beside the septic tank appeared to be empty and SIGIR inspectors noted the pump was running despite the empty tank. Site Photo 8 shows the water pump pressure gauge with no pressure.

**Site Photo 8. Water pump pressure gauge reads zero while running with no water**

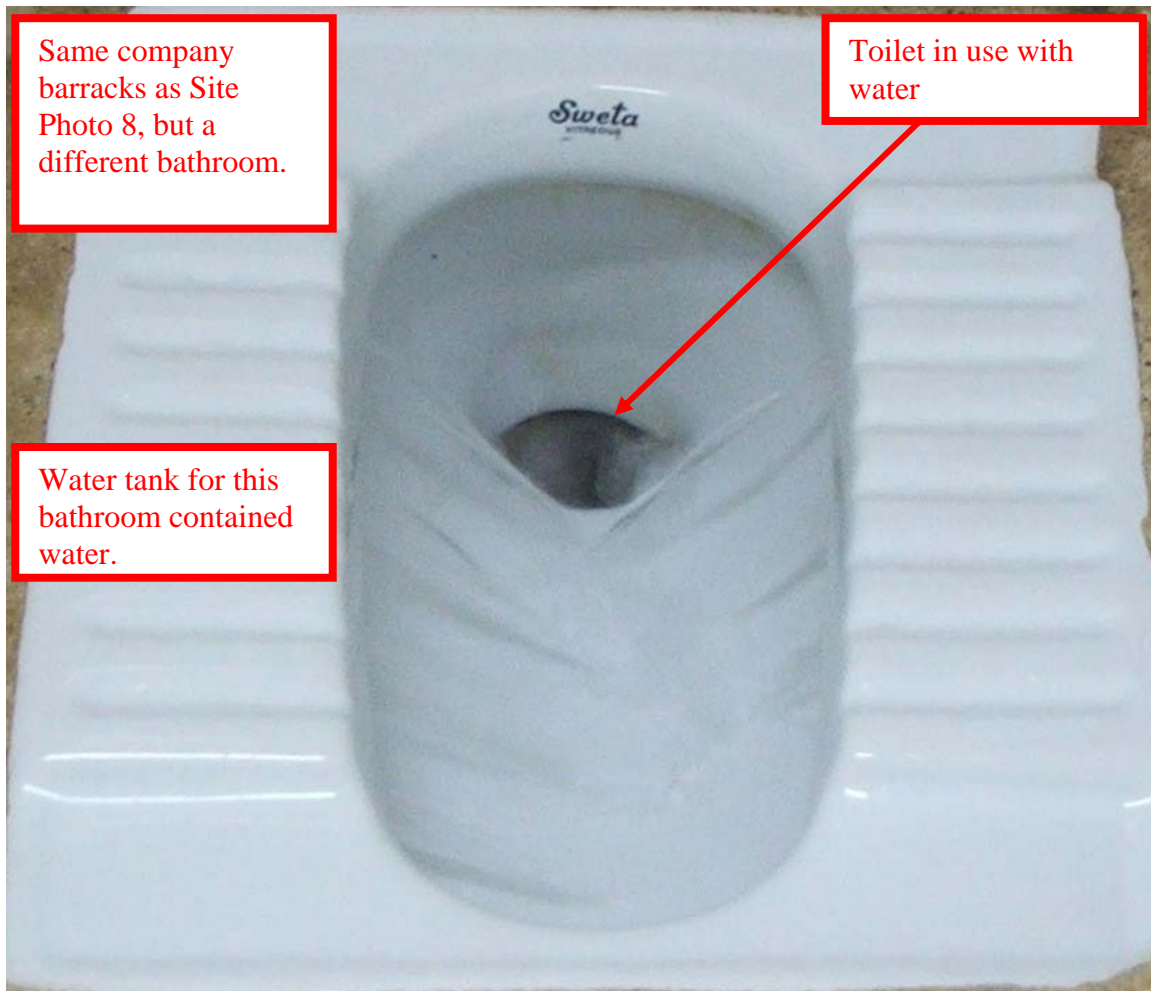
Although water tanks beside one company barracks bathroom contained no water, the barracks other bathroom water tanks were observed to contain water. The bathroom drains, as did the toilets, with flowing water. Site Photo 9 shows water flowing in the other barracks bathroom toilet. This toilet was free from material and dirt.

**Site Photo 9. Toilet in use with water in the company barracks.**

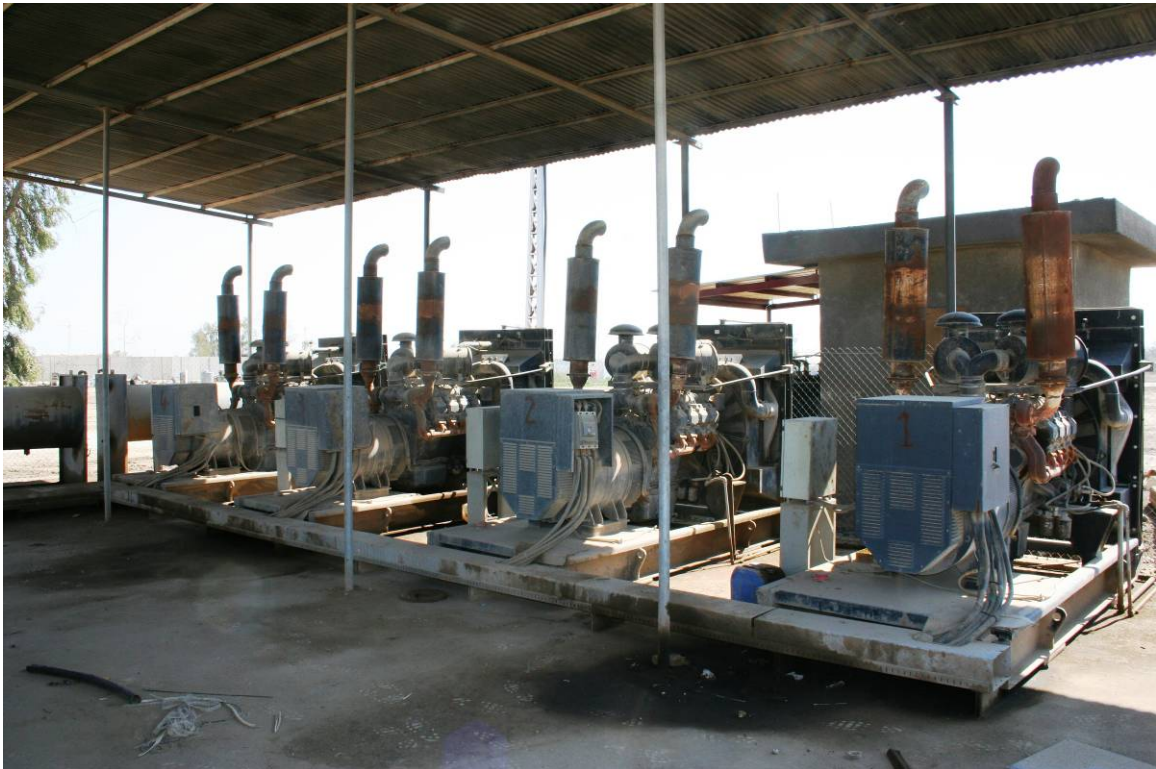
SIGIR inspectors found four 150 kilovolt generators present on site (Site Photo 10.) According to USACE provided documentation, each generator cost approximately \$50,000. The generators included three fuel storage tanks and electrical switching equipment.

All four generators did not function when inspected. Inspection of the generators revealed missing or nonfunctional batteries in all generators. The generators also contained an inadequate amount of oil. In Site Photo 11, a generator shows an empty battery and a dipstick with no oil.

**Site Photo 10. Four generators installed but not operational during site visits.**

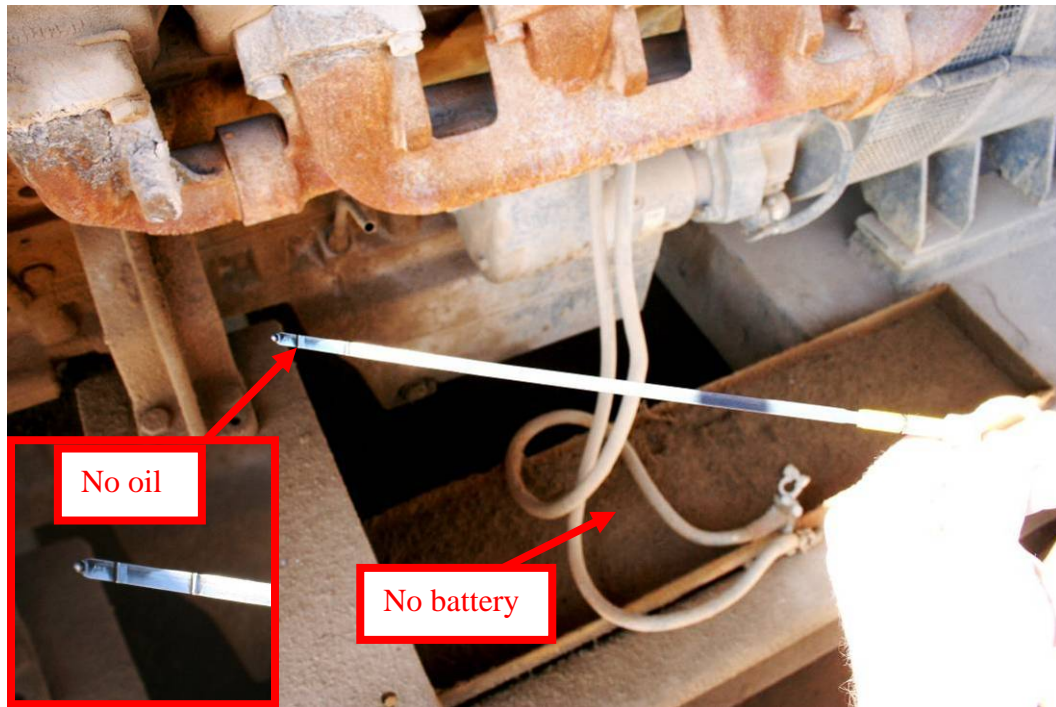
It is likely that the generators were functioning at one time as spots of oil were visible under generators one and three. The exhaust pipes and mufflers on generators one and three also contained a higher degree of rust than generators two and four, which indicated that generators one and three ran more than generators two and four. The nonfunctional generators lacked batteries and oil, and the fuel tanks were empty.

**Site Photo 11. All four installed generators were not operational.**

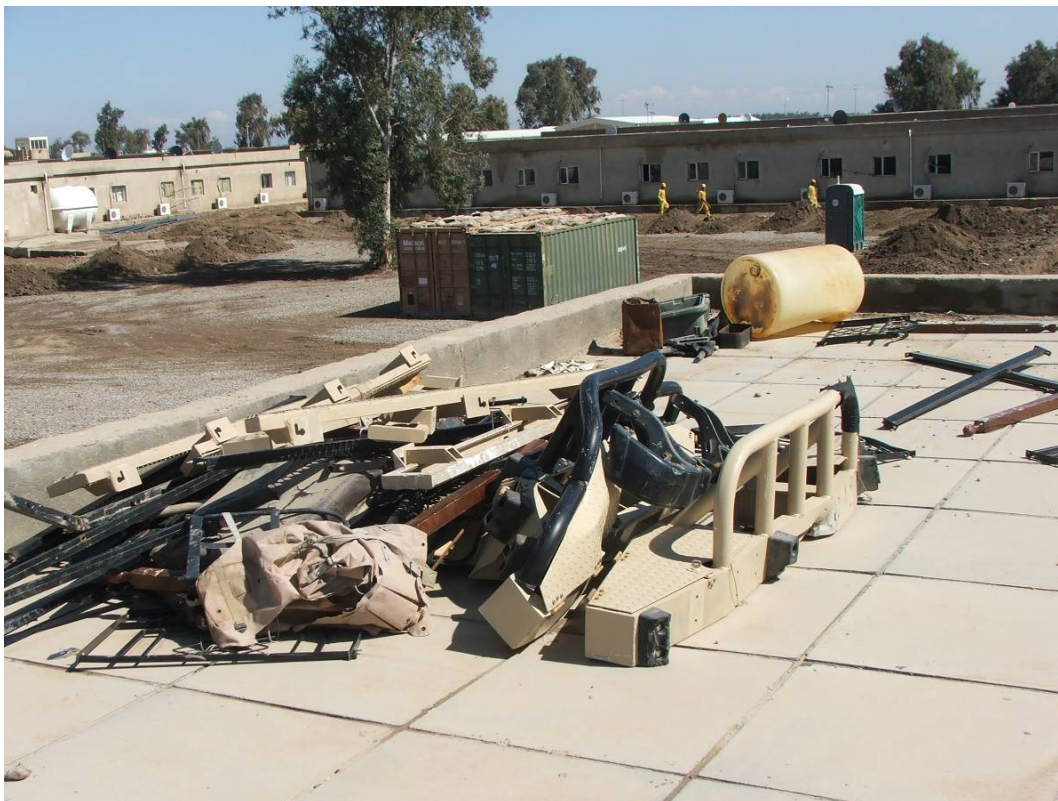
SIGIR inspectors noted that although a good roofing system existed, the roofs of the barracks were used for storage of various items. Site Photo 12 shows parts of beds, heavy vehicle bumpers and other items on the roof of a company barracks. Site Photo 13 shows metal cabinets/lockers and bed frames on the roof of a company barracks.

**Site Photo 12. Old vehicle components, bed frames and other items were placed on the barracks' roof.**

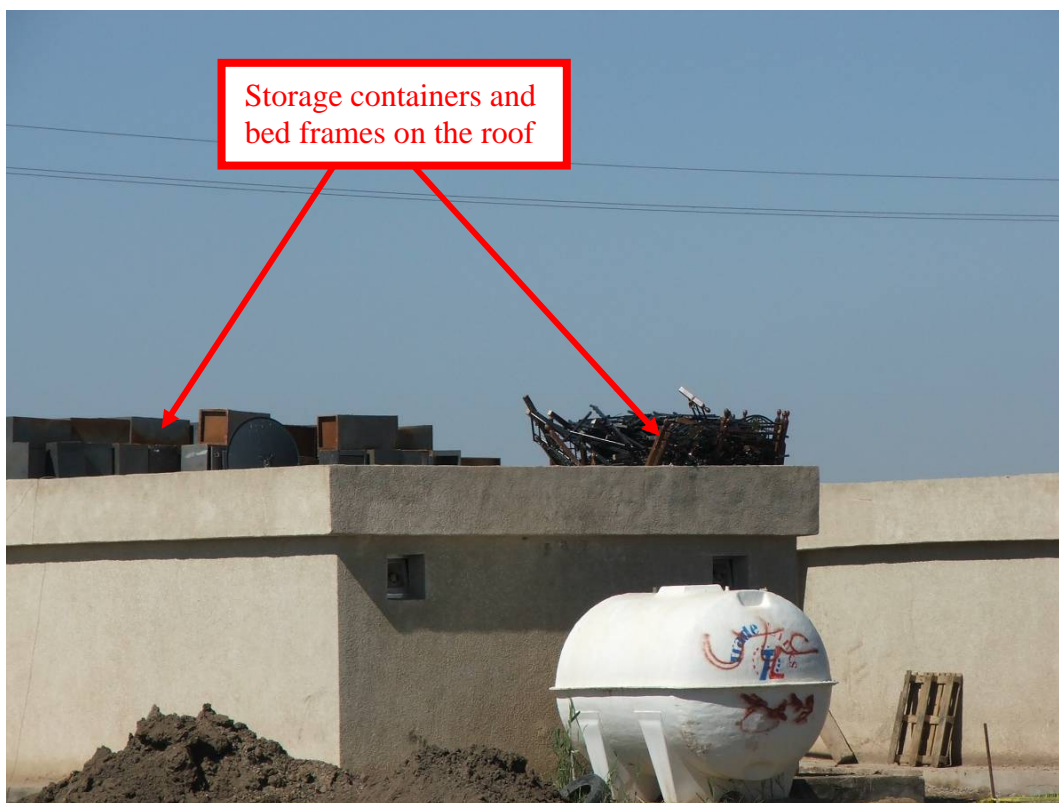
**Site Photo 13. Various items visible on the roof of a company barracks.**

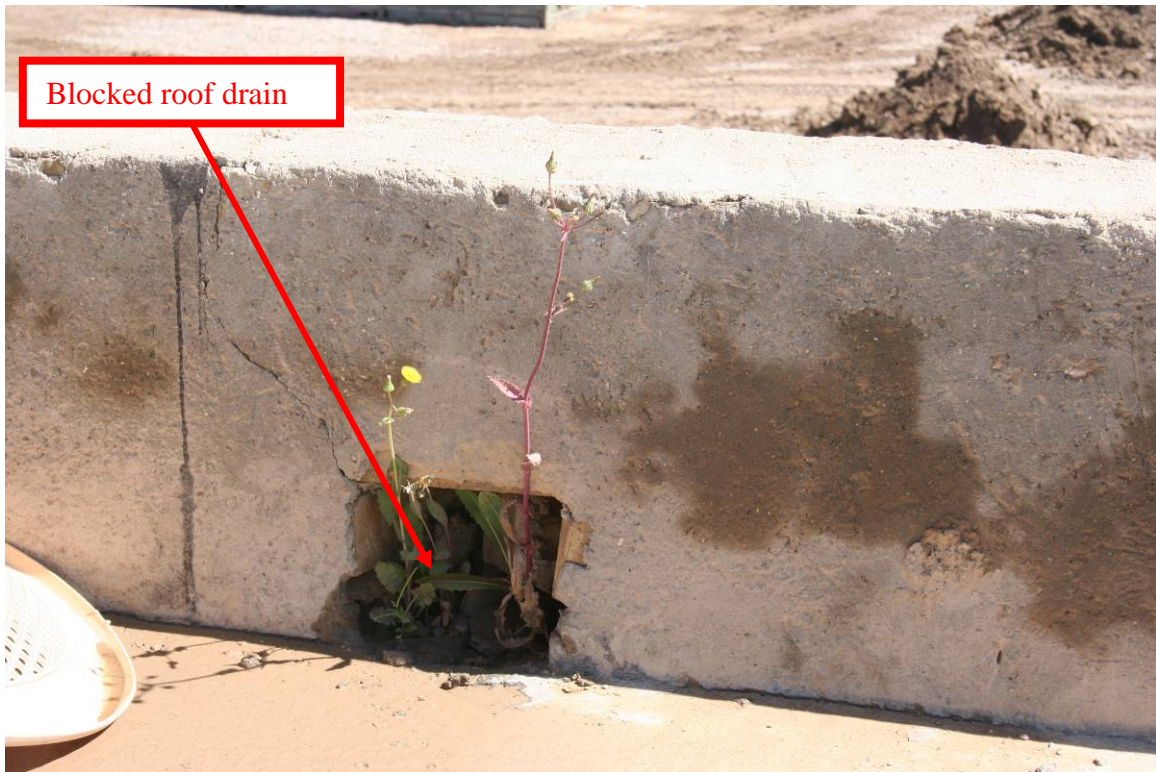
Drains for the roof were found to be blocked by cans, plastic bottles and other debris. Site Photo 14 shows a flowering plant growing from one drain. Site Photo 15 shows another drain area that contained a number of bottles, cans and debris. A number of water stains were noted in this particular barracks. For example, Site Photo 16 shows the ceiling corner of the clinic below the drain seen in Site Photo 15. Water seepage stains were observed, along with what appears to be biological growth.

**Site Photo 14. Plant growth in roof drain blockage.**

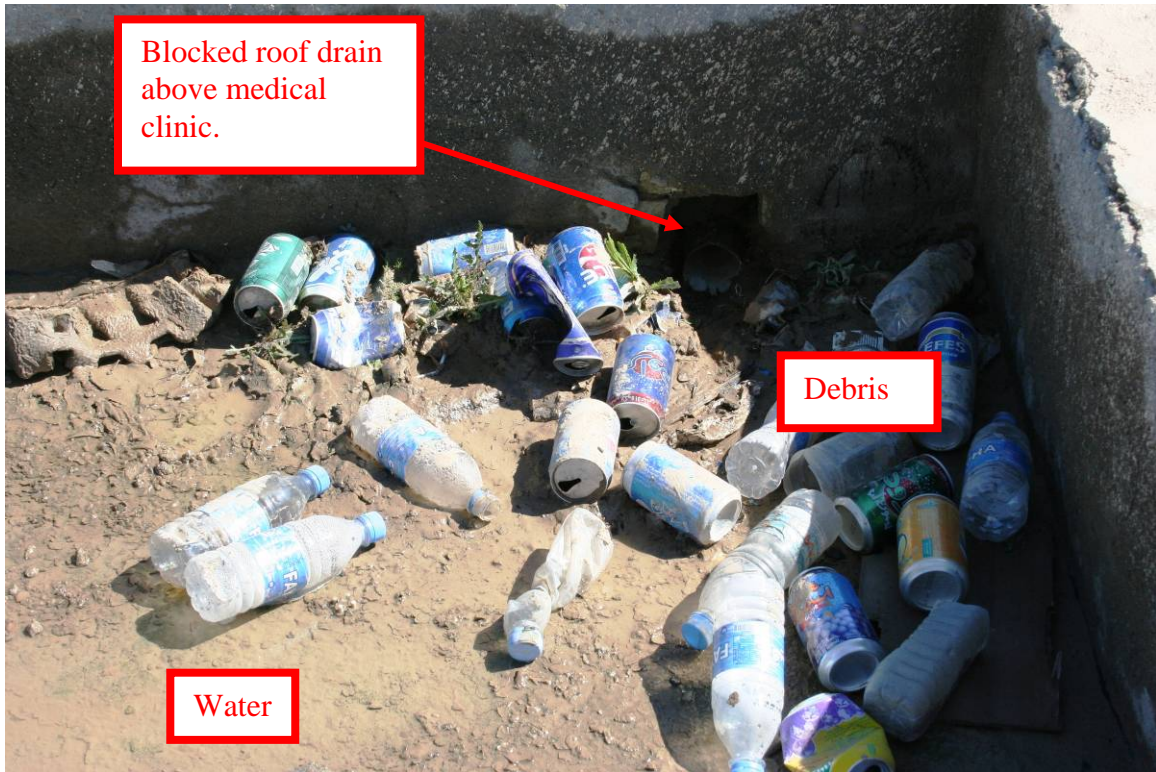
**Site Photo 15. Roof drain blocked above clinic.**
